**SUMMARY APPRAISAL REPORT FOR THE
POTENTIAL SALE OF
TEGA CAY WATER SERVICES, INC.
WATER AND WASTEWATER UTILITY SYSTEM**

GAI# A132116.00/01

Date of Report: 1/29/2014

**CITY OF TEGA CAY
TEGA CAY WATER SERVICES, INC.**

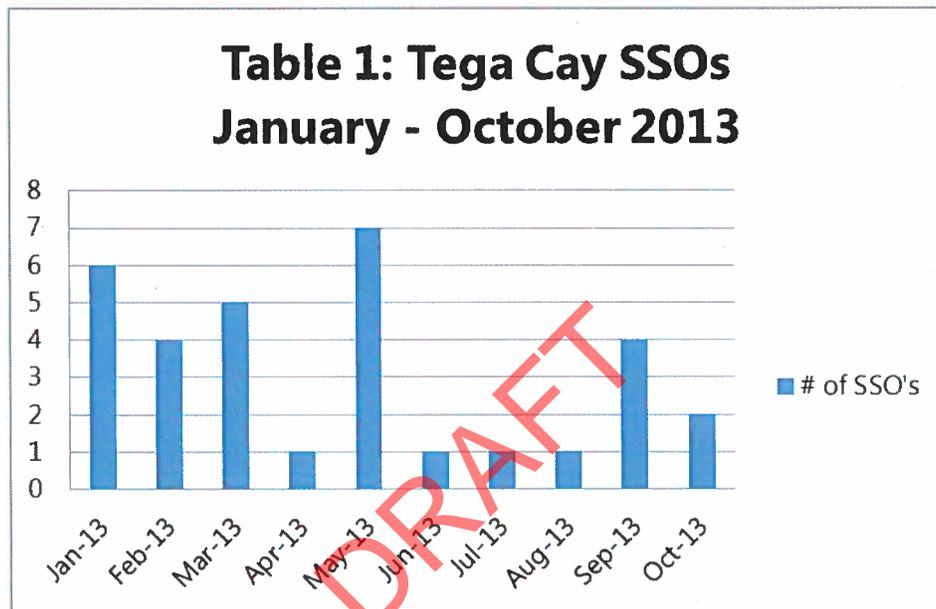
TCWS is required by DHEC Consent Order 11-004-W to report all SSOs to DHEC regardless whether the wastewater reaches a surface body of water, poses a threat to human health or the environment, or exceeds 500 gallons. For the monitoring period January 9 through October 9, 2013, TCWS experienced 32 SSOs.

The volume of wastewater attributed to these SSOs varied from 5 gallons to an estimated 100,000 gallons of partially treated effluent. The largest overflows occurred at WWTP #2 in January and April. TCWS indicated to ORS and DHEC that excessive inflow and infiltration (“I&I”) after rain events triggered the overflows at the ultra-violet disinfectant stage of the treatment process. Of the smaller SSOs, 11 caused service interruptions due to blockage of service laterals by roots, grease and/or toilet paper.

TCWS indicates it promptly notified DHEC of each SSO and took actions to clean up and disinfect the areas affected. No Swimming Advisories were posted near areas affected by the SSOs in February, April, May and September. While TCWS has used its “Voice Reach” system to notify customers of No Swimming Advisories in April 2013, the company did not use the Voice Reach consistently during the monitoring period. Based on information received from TCWS in

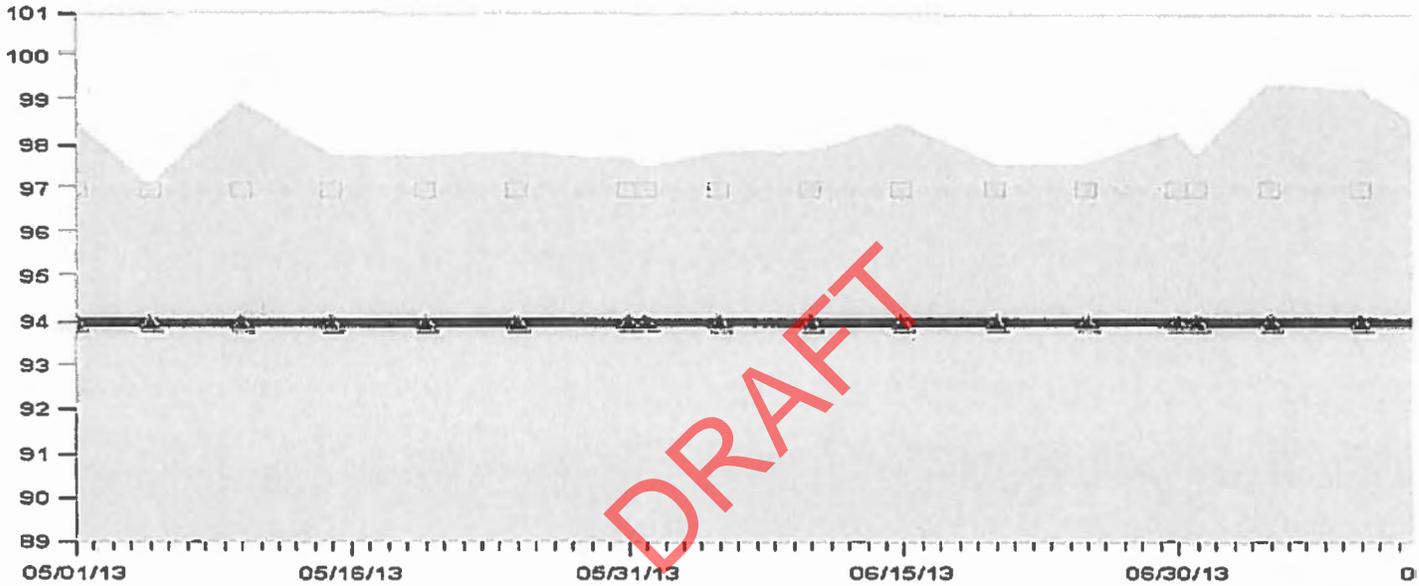
3-Month Lake Level History

<u>Actual (about-lakelevels.asp?#actual)</u>	<u>Target (about-lakelevels.asp?#target)</u>	<u>Min. (about-lakelevels.asp?#min)</u>	<u>Max. (about-lakelevels.asp?#max)</u>
05/01/2013	98.4	97.0	94.0	00.0
05/02/2013	98.1	97.0	94.0	00.0
05/03/2013	98.0	97.0	94.0	00.0
05/04/2013	97.6	97.0	94.0	00.0
05/05/2013	97.0	97.0	94.0	00.0
05/06/2013	99.2	97.0	94.0	00.0
05/07/2013	99.8	97.0	94.0	00.0
05/08/2013	99.8	97.0	94.0	00.0
