WASTEWATER TREATMENT PLANT FACILITY EVALUATION INSPECTION REPORT

NPDES #: SC0031399

Piney Grove Utilities/Franklin Park S/D

Wastewater Treatment Facility Operation & Maintenance Evaluation Report

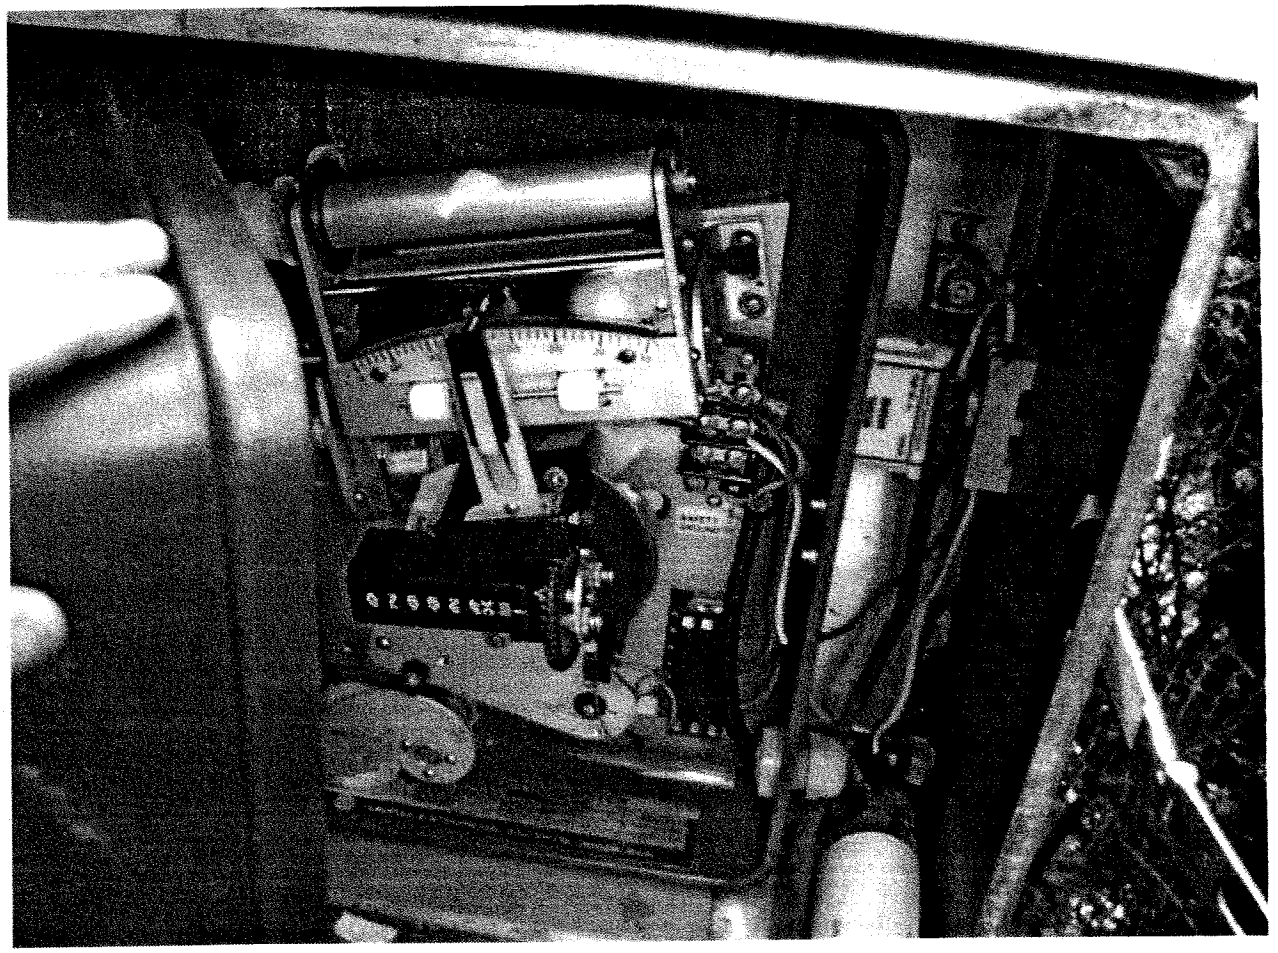
Ben Mustian - 040805 Lloydwood SD-Final effluent with no disinfection discharging over weir to ditch, to creek, between Page 1.
