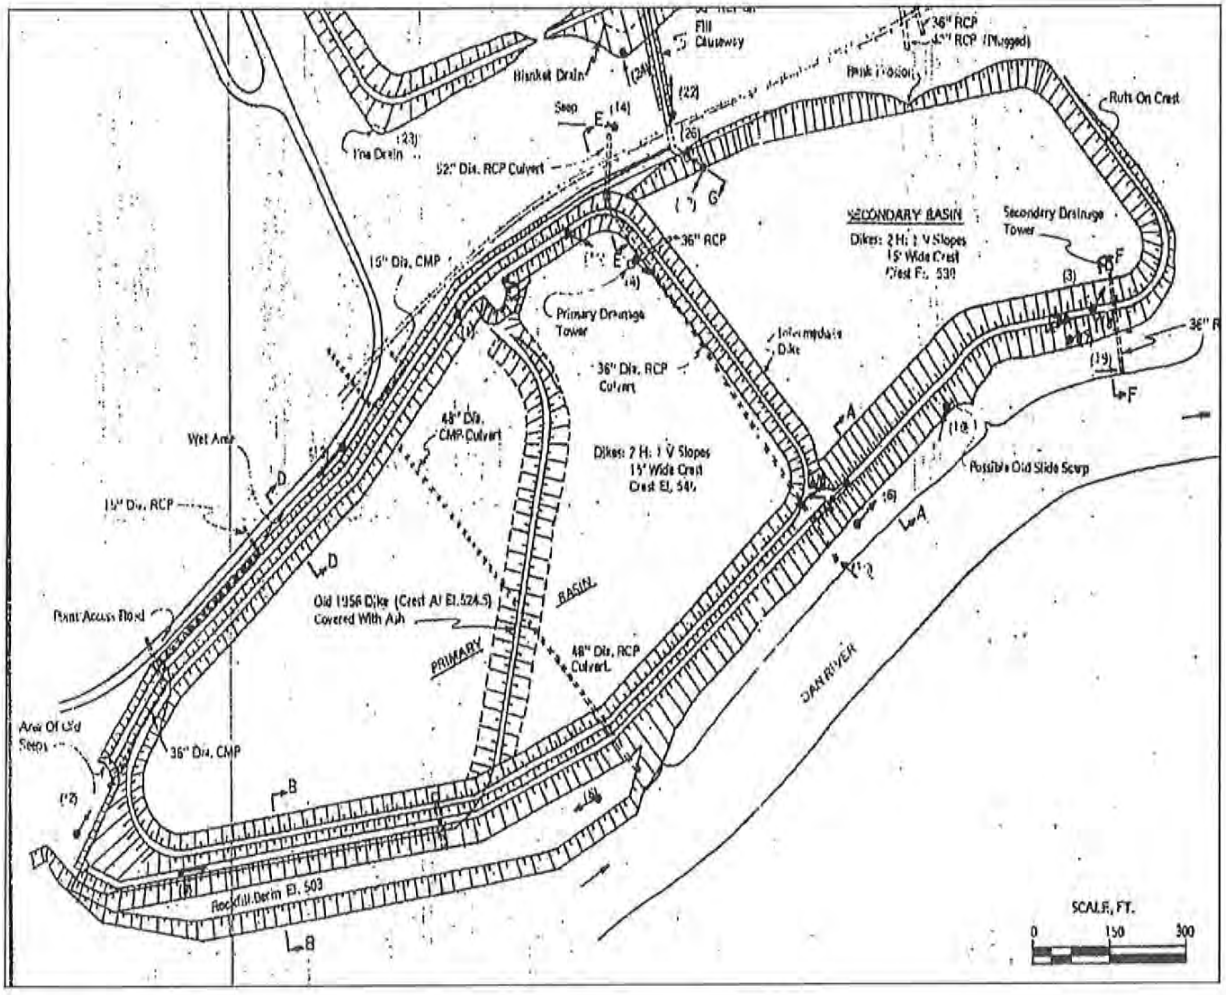
Diagram 1. Engineering Firm #1, Report of Safety Inspection – Duke Power Dan River Steam Station Ash Dikes, at Fig. 4 (1981).

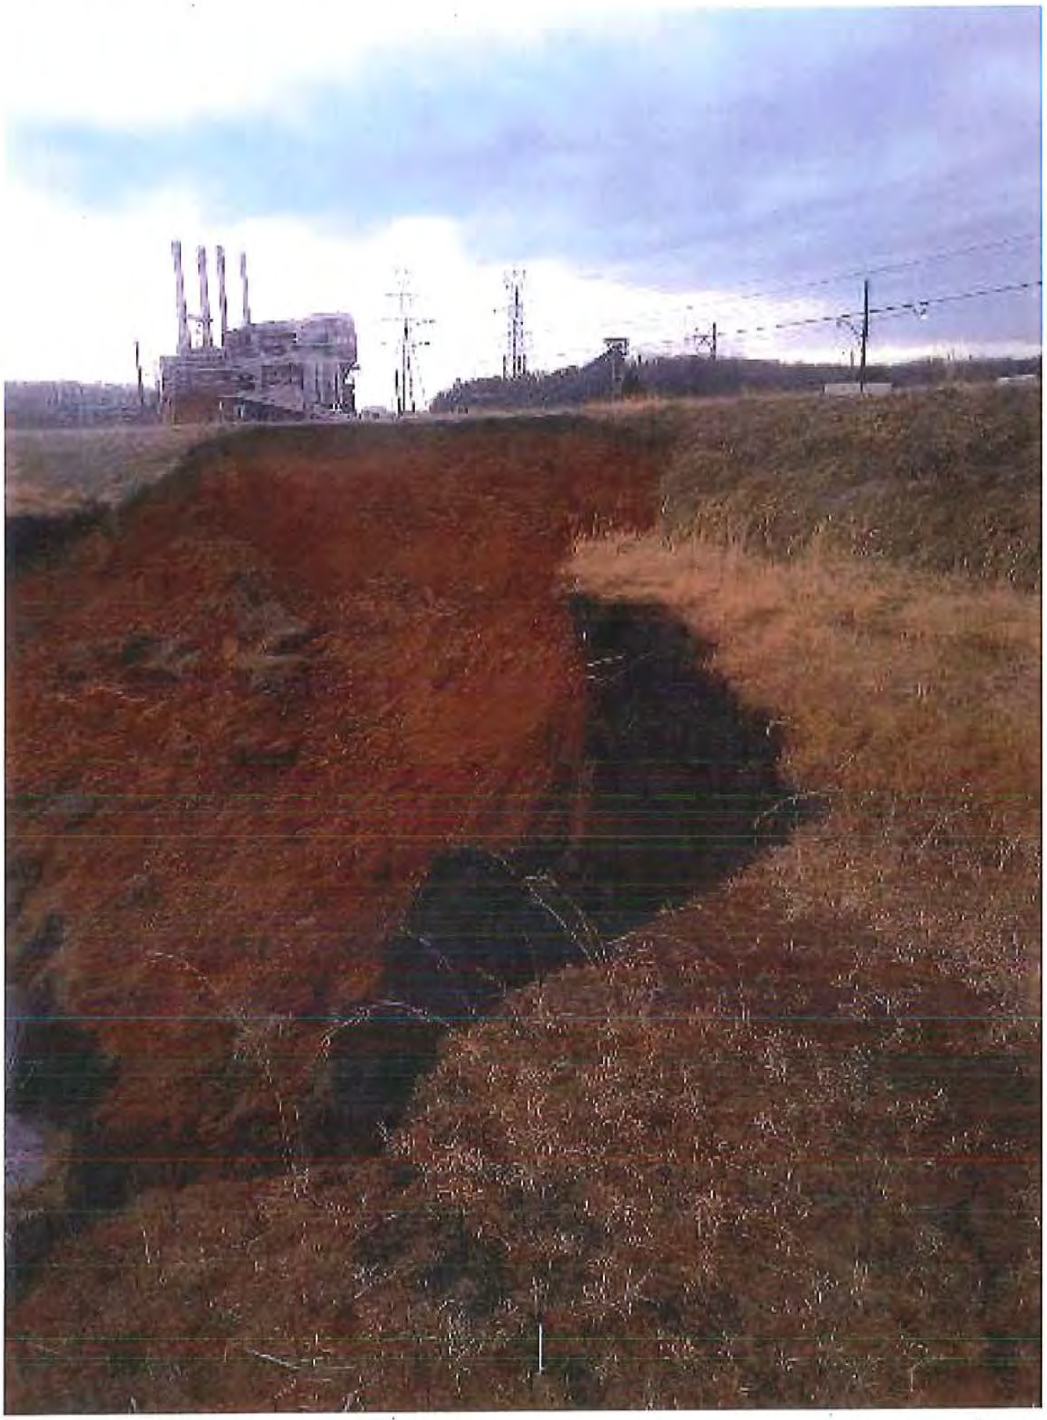
Photograph 1. Photograph of DAN RIVER coal ash basin during spill, attached to 2/2/2014, 3:49 p.m. e-mail from Duke Energy Business Services employee.

81. On February 2, 2014, a five-foot long elbow joint within the sixty-year-old corrugated metal section of the 48-inch pipe under the Primary Ash Basin at DAN RIVER failed, resulting in the release of coal ash wastewater and coal ash into the Dan River.

82. Later inspection of the elbow joint, after its retrieval from the Dan River, revealed extensive corrosion of the metal of the elbow joint initiating at the bottom center of the elbow. The parties disagree about some of the factors that contributed to the extensive corrosion. Nevertheless, the age of the pipe was at or beyond the reasonably expected serviceable

life for CMP under similar conditions. Ultimately, the combination of the corrosion and the weight of the coal ash basin over the elbow joint caused it to buckle, fail, and be pushed through the end of the 48-inch stormwater pipe into the Dan River.

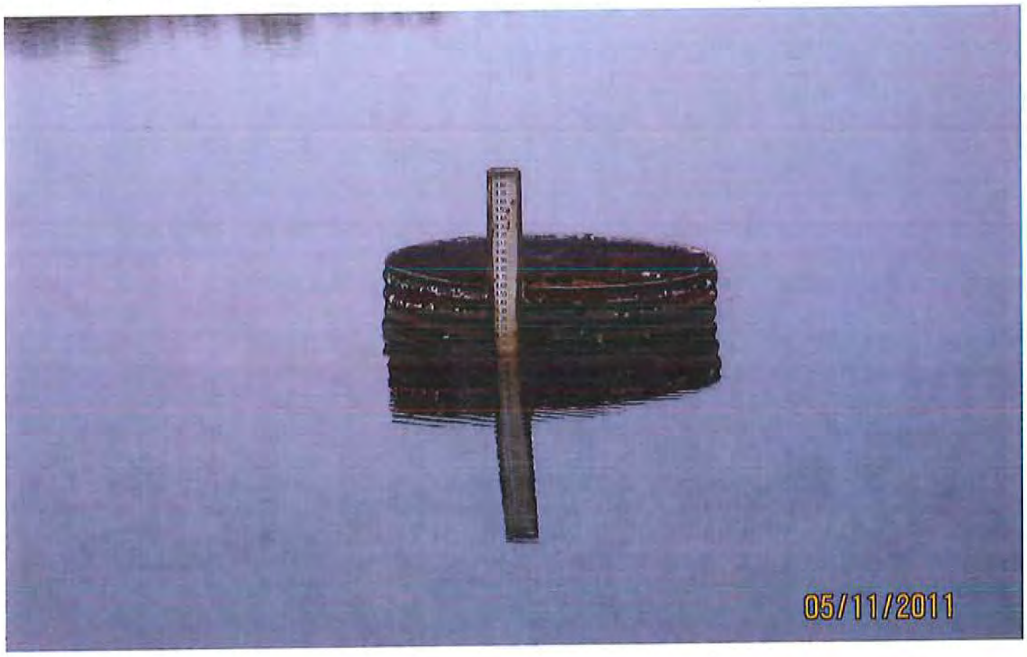
110. The 2012 Five-Year Independent Consultant Report, produced on January 26, 2012, by Engineering Firm #4, noted that the skimmer located at the top of the riser in the 1978 ash basin was corroded and tilted. The skimmer was designed to

113. Annual inspection reports for 2012 and 2013 also reported that the riser in the 1978 ash basin was damaged, deteriorated, and tilted. The annual reports recommended that DUKE ENERGY PROGRESS/Progress Energy Carolinas replace or repair the skimmer on the riser in the 1978 ash basin.

Photograph 6. Riser in CAPE FEAR 1978 coal ash basin from 2012 Five Year Independent Consultant Report.

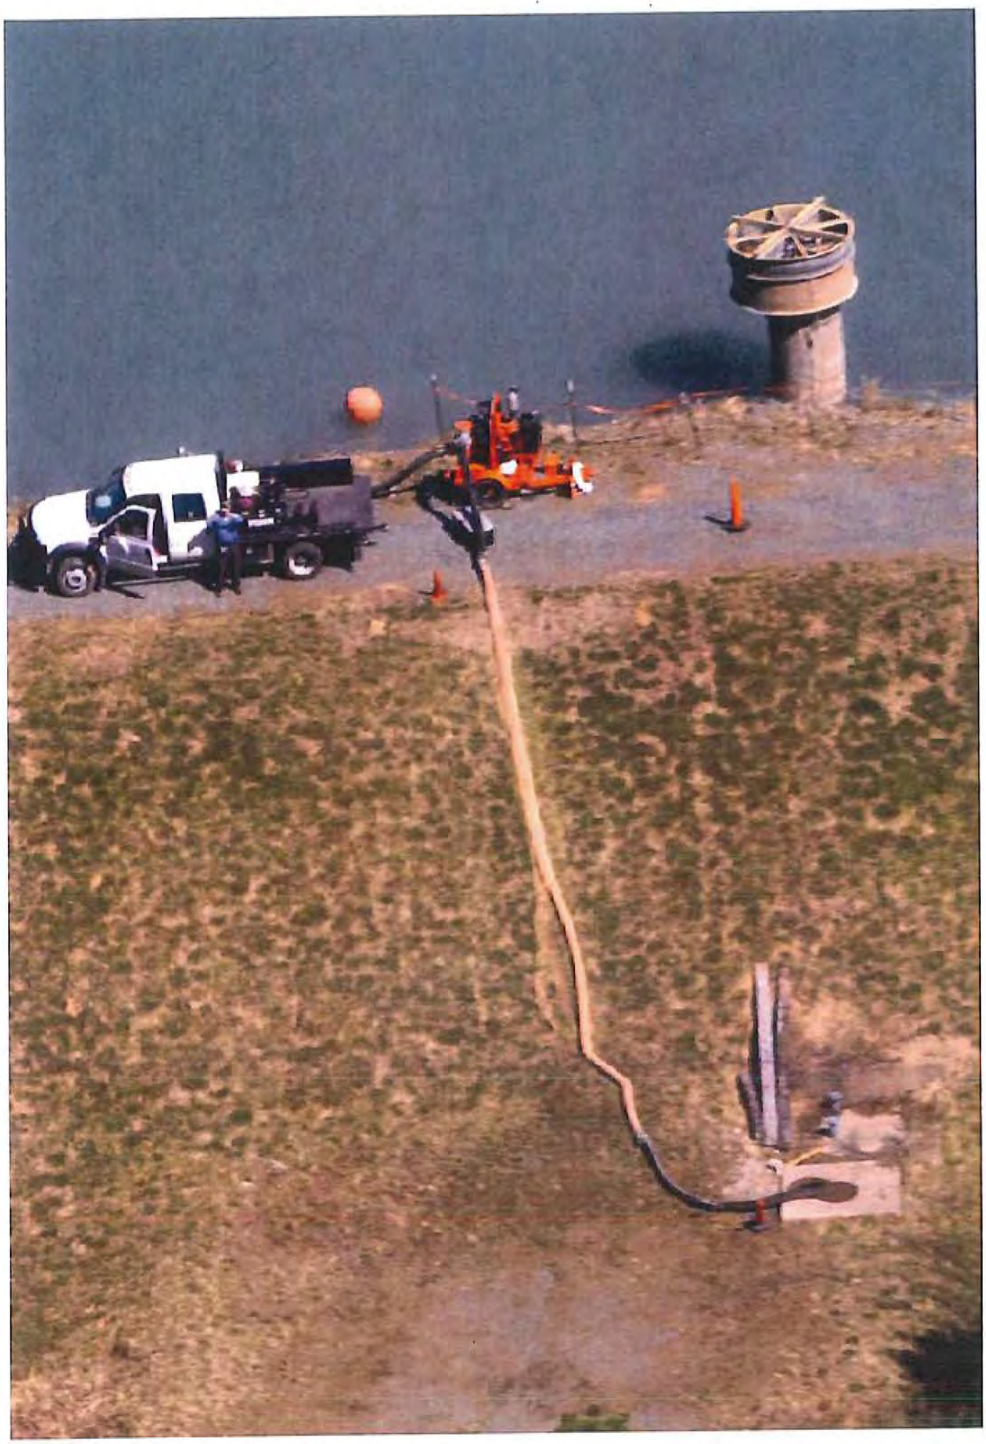
127. On or about March 11, 2014, DENR officials from both the DWR and the Division of Mineral and Land Resources visited CAPE FEAR to perform an inspection. The DENR officials were accompanied by several DUKE ENERGY PROGRESS and DUKE ENERGY BUSINESS SERVICES employees during their inspection. DENR observed the Godwin pumps at the 1985 and 1978 ash basins along with obvious signs of a significant drop in the water level in the coal ash basins and disturbances in the surface of the coal ash in the basins. **(See Appendix, Photographs 8 - 10).**

Photograph 9. 3/11/14 aerial photograph of CAPE FEAR 1985 coal ash basin with Godwin pump and truck.

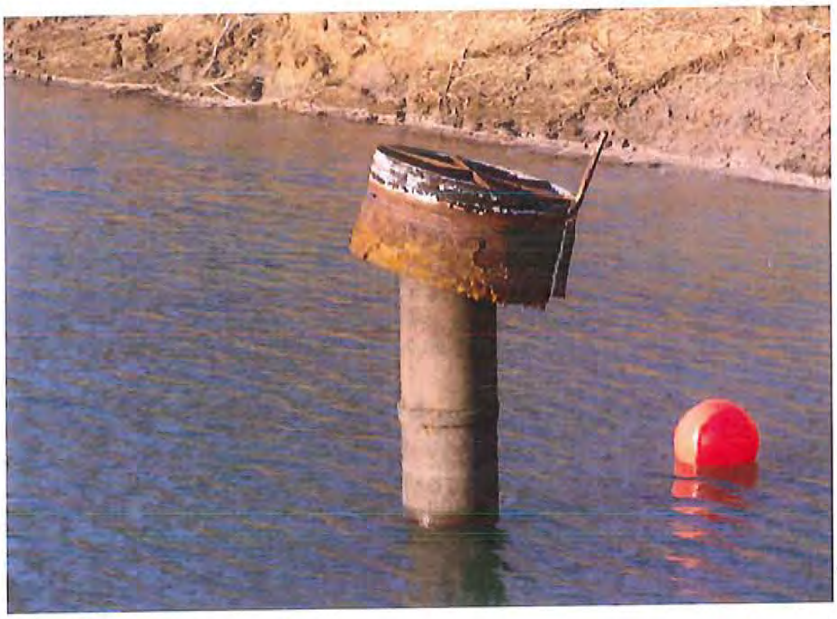
for contractors performing repair work. DUKE ENERGY PROGRESS and DUKE ENERGY BUSINESS SERVICES employees knew that the leaks in the risers were likely being caused by cracks or failures in the grout between the concrete pipe sections that were underwater. The employees did not know how far underwater the leaks or grout failures were or how many sections of the pipe would need repair. Because the risers were filled with air but surrounded by water, underwater repair of the risers could be hazardous to the divers due to a phenomenon known as "differential pressure." DUKE ENERGY PROGRESS and DUKE ENERGY BUSINESS SERVICES employees believed that removing the standing water from the 1978 and 1985 basins to at or below the level of the leaking portions of the risers would eliminate the risk from differential pressure.

Photograph 11. 3/19/14 photograph of CAPE FEAR 1978 coal ash basin riser, prior to repair work.

131. On or about March 19 and 20, 2014, employees and agents of the underwater pipe repair contractor replaced and resealed the grout between the concrete pipe sections of the risers in the 1978 and 1985 coal ash basins. **(See Appendix, Photographs 11 through 14).**
